Electrical Energy & Safety Audit Report of Mangaldoi Commerce College, Mangaldoi, Assam

Audit Period: 31/03/2022-04/04/2022

Audited by: MRINMOY BORUAH ENGINEERING

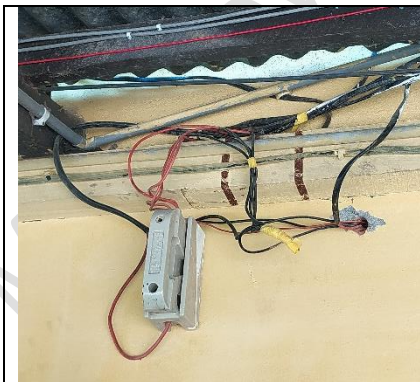
- The primary source of power supply to the college campus is from an Overhead LT Grid Supply cable.
- The LT grid supply cable is fed to a 100A Fuse, mounted on a wall at the corridor outside the Office room. There is no MCB/MCCB protection at the LT Grid supply input.

Photo: 100A Fuse at grid supply incomer

- 1) An MCB switch of appropriate rating should be installed at the LT Grid supply input, in place of the existing 100A fuse. The fuse protection system currently being used is not sufficient to ensure safety of the power distribution system of the college.
- 2) A distribution board (DB) should be installed for power distribution to the various rooms of the college campus. This main distribution board should have MCB switches of appropriate rating for each of the circuits outgoing to the different rooms of the college.
- 3) The DBs installed at the various rooms of the college have isolators as their Main Incomer Switch. These isolators should be replaced by MCB switches of appropriate ratings.
- 4) A complete revamping of the earth arrangement is necessary.

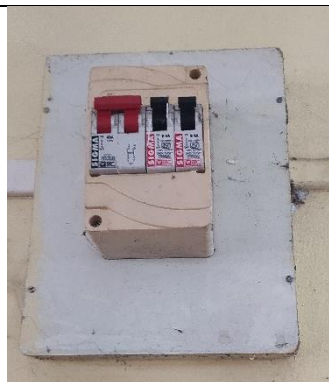
- Multiple tapplings are taken from these outgoing circuits to provide power supply to the different rooms. There are distribution boxes (DBs) installed at the different rooms for their power distribution. The Main incomer switch of each of these DBs are isolators. These isolators do not provide any protection for these circuits.

Photo: DB at Room #9:
1 x 40A DP Isolator (Main Incomer)
2 x 6A SP MCBs (Outgoing)

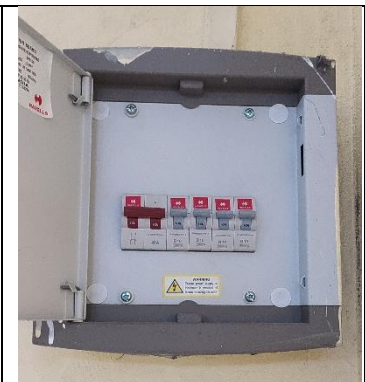
Photo: DB at Room #7:
1 x 40A DP Isolator (Main Incomer)
4 x 10A SP MCBs (Outgoing)

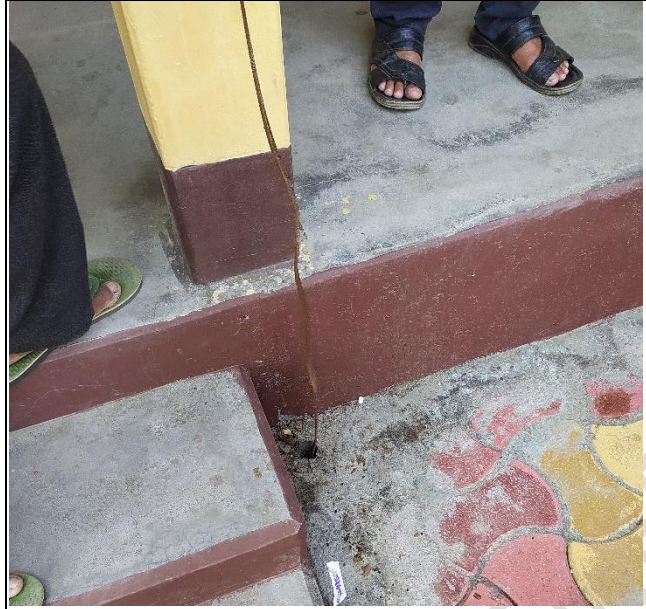
Photo: Earthing strip connected to the earth-pit buried underground.

- There is only one earth-pit installed for the entire college campus. This earth-pit is untraceable as it has been buried under concrete cover
- There is a Copper earthing strip drawn out from this earth-pit. The earth resistance value was checked at this copper strip and found to be **38 Ohm**. The earth resistance value of this earth-pit is extremely high.
- There are copper multistrand wires used as earthing conductors to provide earthing connection to the switchboards at few of the rooms of the college campus. These copper wires are not connected to the earthing strip.

Essentially there is no earthing connection for the entire college campus.

New earth-pits should be constructed at easily accessible locations in the college campus. Concrete earth-pit protection chambers having a hinged CI cover should be constructed for these earth-pits.

Earthing connections should be provided for each of the switchboards and DBs at each room of the college campus. The earthing conductors should be neatly drawn to the earth-pit and securely fastened to the earth-pipe.

The earth-pits should be regularly watered to keep the earth resistance values at a minimum. A funnel should be installed for pouring water into these earth-pits.

A complete revamping of the earthing arrangement is necessary.
